HEAVY DUTY WATERPROOF 3P XLR ADAPTER Sample Name

Product Specification RX3FWP RX3MWP

No.	Test Item	Test Method	Result	Conclusion
1	IP6KX	ISO 20653:2013	See result	Pass
2	IPX6	ISO 20653:2013	See result	Pass

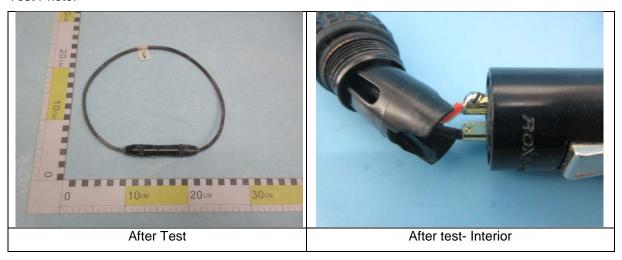
Test Photo:

Sample No.	Result	Client's requirement	Conclusion
	There was no visual ingress of	There is no visual ingress of	
001	dust in the welding spot and	dust in the welding spot and	Pass
	inside of the screw sleeve	inside of the screw sleeve
